Full scale tests of underground and earth-covered loading and response systems subjected to the effects of nuclear weapons were made during the period of 1951 through 1958. Much of this data has been scattered through classified and unclassified literature without any previous attempt at correlation or cross reference purposes for use by researchers in the field of structural dynamics and weapons effects testing.

This document includes, in one volume, all available pertinent data arranged in order of test operation, but cross reference indexed by functional categories. Each entry includes project and structure identification, cross reference listing, report references, project objectives, structural description, structural details, soil characteristics, shot information, the test layout, loading data, a summary, other remarks, and subsequent testing. This information is then correlated in a series of charts designed to show quickly and graphically the relation between similar tests, and so arranged that positive trends in structural response become apparent. A general discussion and recommendations are presented. Maps of the Eniwetok Atoll and the Nevada Test Site are included to

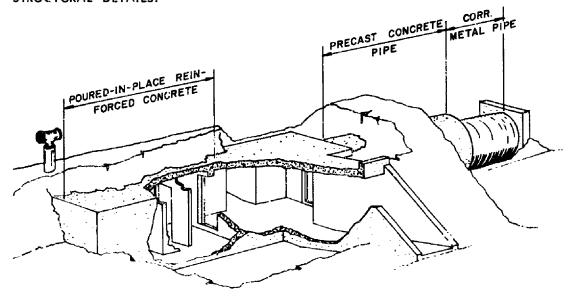
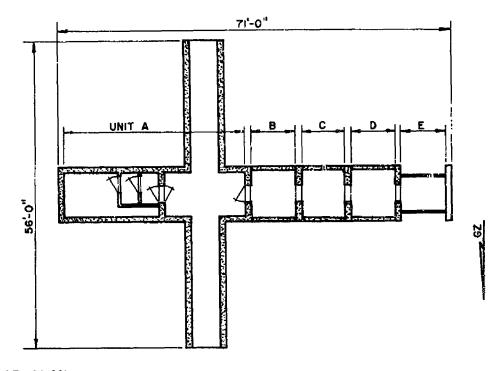
There was insignificant damage for shot "Easy"

The three precast sections were designed with varying strengths in an attempt to insure plastic action in at least one of them. None of these precast sections suffered damage that could be determined by visual inspection.

In spite of the very light metal used in the corrugated pipe section of the shelter, no permanent plastic deformations were observed.

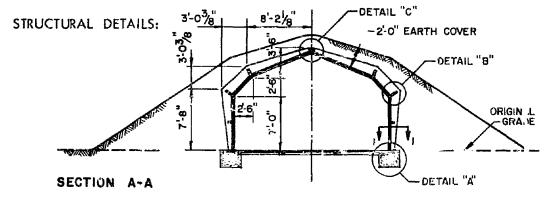
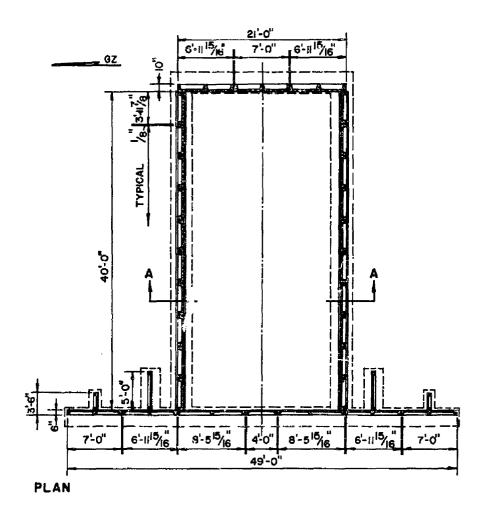
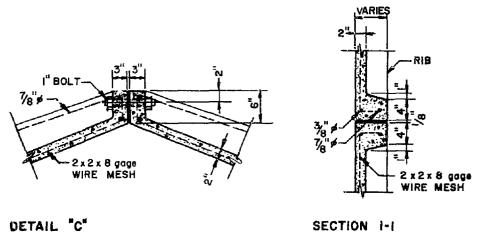
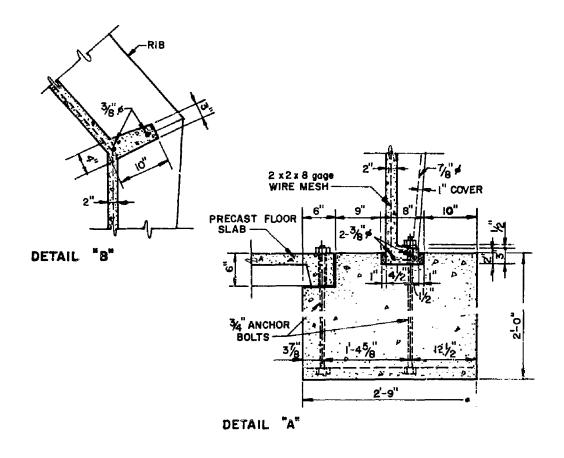
It was predicted that greatest damage would occur in frames at the crown of the roof. Cracks at haunches were anticipated.

The earth cover on Structure 3.2.4a, especially the heavy embankments against the vertical faces of the side walls, caused the structure to respond in a manner slightly different from the predictions. It was thought that the pressure loading would produce a response similar to that obtained in an uncovered arch type structure, namely a slight flattening out of the windward panels with tension stresses on the inside and compressive stresses on the outside, as well as a tendency to squash the leeward panels with tension on the outside and compression on the inside. However, the flat sloping roof portion of the windward panels received a heavier load than the vertical face; and the sloping portion attempted to move downward, introducing large moments at the knee of the panel with consequent cracks on the outside of the knee and none on the inside. On the leeward wall panels, tension cracks appeared on the inside face near the base and also at the fold lines. The end panels that remained in place developed shear stresses and cracks, as predicted, and to just about the extent predicted.

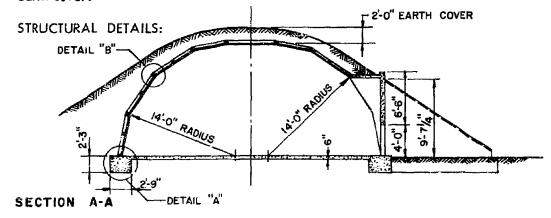
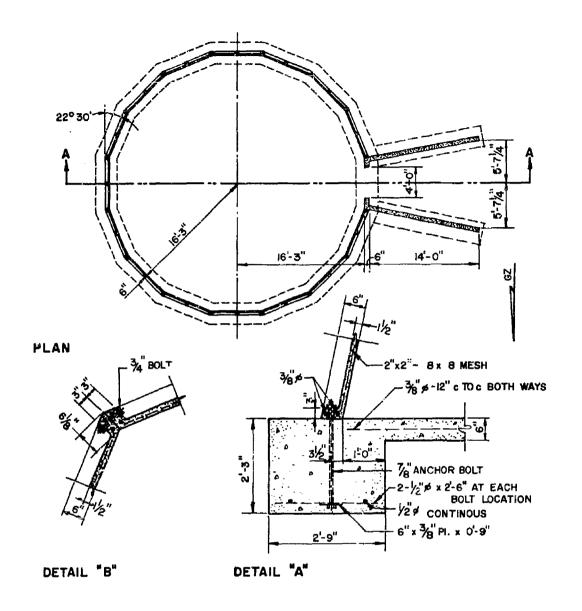
The structure suffered only minor damage (permanent vertical deformations of 3/4" maximum) under the applied loading. Slight displacement of panels occurred relative to each other. Most of the earth cover remained in place; however, the middle section of the earth was thrown out. The door to the structure was slightly deformed, but the wing walls were undamaged. Failure in the panels of this structure was limited to a plastic change at some joints. 'rregularities in casting and shrinkage caused the panels to bear on each other at the corners. Further, column action of the ribs in the vertical plane during vertical deflection and of the ribs in the horizontal plane during wracking caused plastic strains at the intersections.

There was no attenuation of pressure in the two feet of cover on top of Structure 3.2.6. However, decreased pressures were observed on the walls, depending upon amount of cover.

This particular structure was uncovered and subjected to similar loading during Shot "Item". Similar conditions of range and pressures existed; however, the structure was severely damaged. Four of the lower panels on the side of the structure facing the shot were demolished.

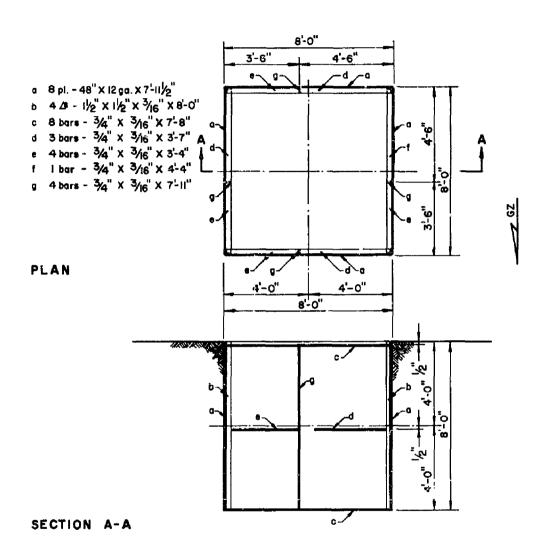
3.21 a1 and a2 — Light Metal Steel Cell

The walls of the metal cells were observed to have bowed inward as much as 9 inches at the top and 4 inches at the center. However, considerable difficulty was encountered during the construction period in attempting to keep the cells from deflecting excessively under the static soil pressures and it was not possible to determine, by visual examination alone, what portion of the observed displacement was caused by the explosion.

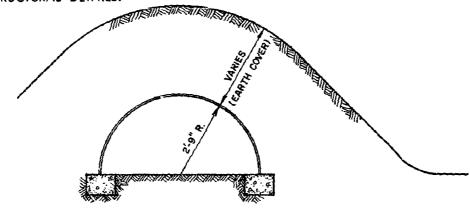
Shot "Baker"	Damage
shelfer b-1	Heavy Damage. End section pushed in at bottom. Arch twisted 6" to 12" out of line but intact. Entrance almost impassable — folded. Cover reduced 18" to 24".
shelter b-2	Arch twisted. Cover reduced 15" to 18".
shelter b-3	Cover remaining 6" to 9". No damage.
shelter b-4	Cover remaining 9" to 12". No damage.
shelter b-5	Cover remaining 9" to 12". No damage.
Shot "Charlie"	Damage
shelter b-1	Complete Destruction. End section and entrance demolished.  Shelter filled with material.
shelter b-2	No change in position of arch; arch completely stripped; some soil blown in open end.
shelter b-3	End wall uncovered and opened up. Partially filled with soil; practically all cover removed.
shelter b-4	Arch twisted; end section demolished; practically all cover removed.

shelter b-5	No change in arch; partly filled with soil; practically all cover removed.
Shot "Dog"	Damage
shelter b-1	Complete Destruction. No change; structure completely stripped.
shelter b-2	Arch tilted away from ground zero; end section demolished; partially filled with material.
shelter b∘3	Arch tilted away from ground zero; end section demolished; completely filled with material.
shelter b-4	Arch tilted towards ground zero; end section demolished; partly filled with soil.
shelter b-5	End section demolished; completely filled with soil.

The structural instrumentation used did not provide significant data for any analytical response considerations. Because the ends of the arch sections were open, significant build-up of internal pressures occurred; thereby automatically increasing the resistance of the structures. These structures were not repaired after each test.

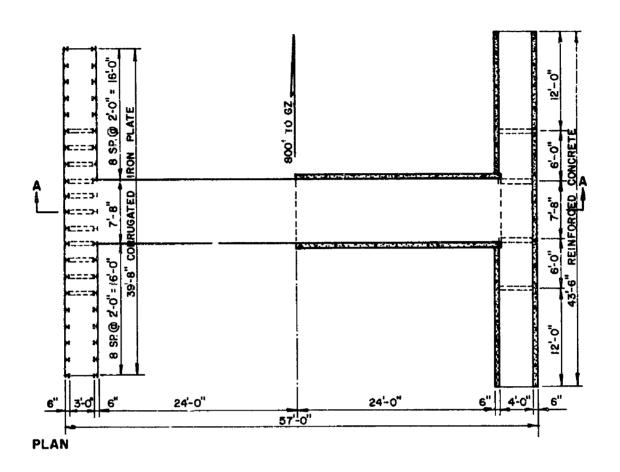
Shot "Baker" produced light damage and insignificant movement of earth cover. The maximum vertical deflections were 1.14 inches for the metal pipe and 1.24 inches for the concrete pipe. Permanent displacements were 0.44 inches for the metal pipe and 0.56 inches for the concrete pipe.

Shot "Charlie" removed a considerable amount of earth cover and large quantities of soil flowed down the ramps and into the pipe ends. No damage was observed in the metal pipe. The maximum vertical deflection was 0.74 inches, and an additional permanent displacement of 0.16 inches was observed. The concrete pipe was undamaged. The maximum vertical deflection was 0.68 inches, and no additional

permanent displacement was observed.

Shot "Dog" removed the remaining earth cover and filled the pipe ends to approximately 50 percent of their original area. The metal ramp was collapsed and the struts at the concrete ramp were damaged. Maximum vertical deflections were 2.72 inches and 2.10 inches for the metal and concrete pipes respectively; and permanent displacements were 0.60 inches and 0.93 inches in addition to the displacements produced by the previous shots.

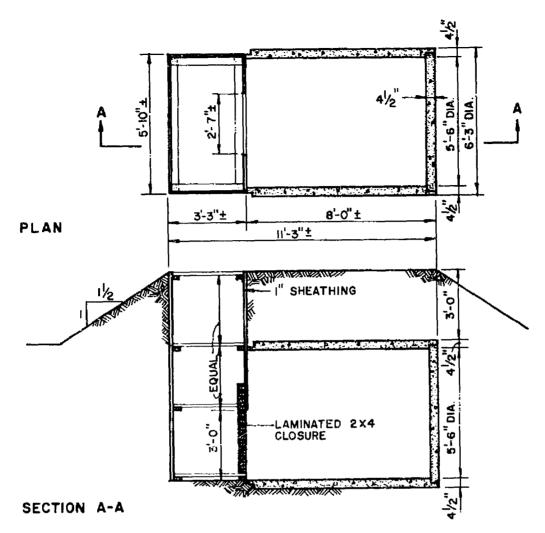
21.1g — Concrete Pipe With Closed Shaft Entrance

A concrete pipe with a closed shaft entrance and three feet of earth cover was used as one of the shelters. (21.1g)

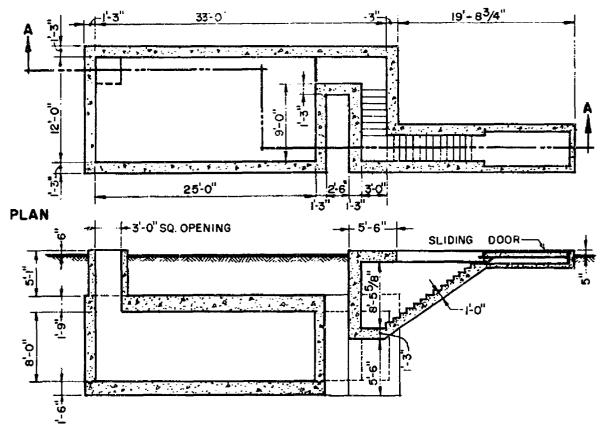
Structure 34.3 al

Neither shelter suffered any visible damage. Appreciable dirt and missiles littered the stair wells. There was a separation between the grout under the steel plates that served as supports for a concrete sliding door and the walls of the stair well of the structural shelter.

The concrete sliding door was used only on the structural shelter (34.3 a1) and showed no evidence of damage. The bars that served to lock the door against an upward motion caused by negative pressures showed no distortion. The rubber mat between the door and the stair well blew onto the steps. The Navy type door and escape hatch in the structural shelter were undamaged.

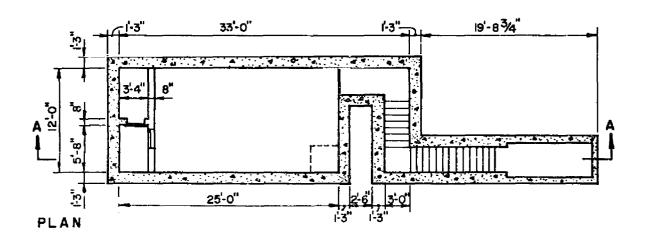
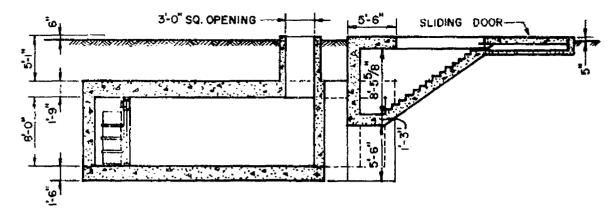
Structure 34.3 a2

Again, neither shelter suffered structural damage at the peak incident pressure of 92 psi, but dirt and missiles littered the stair wells. The blast tore off the vent tee at the junction of the tee and the vertical pipe.

Station 34.3 a2: The Army Chemical Corps ventilation equipment suffered no discernible damage. The failure of one of the rebound bolts from shearing of the thread indicates that these bolts were loaded to the limit of their capacity at the test pressure. An increase in bolt diameter, and therefore thread capacity, would supply a reserve strength to the rebound connection.

Two wheels of the sliding door were destroyed by missiles, and the rubber door bumper blew into the stair well. Destruction of the wheels can be prevented by widening the door slab to provide a protective lip for the wheels. Despite the loss of the wheels, the door could have been jacked open from the inside. The retaining wall around the concrete door was damaged.

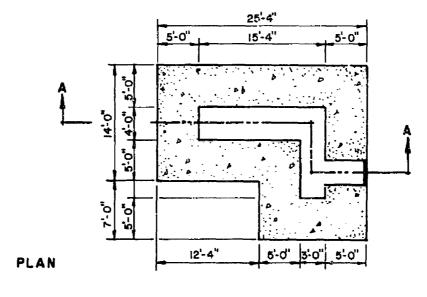
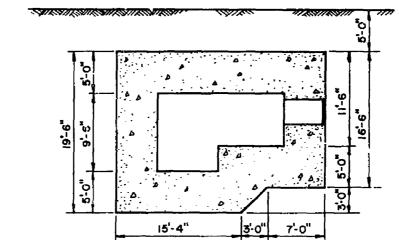
SECTION A-A

Earth cover blown away; no damage.

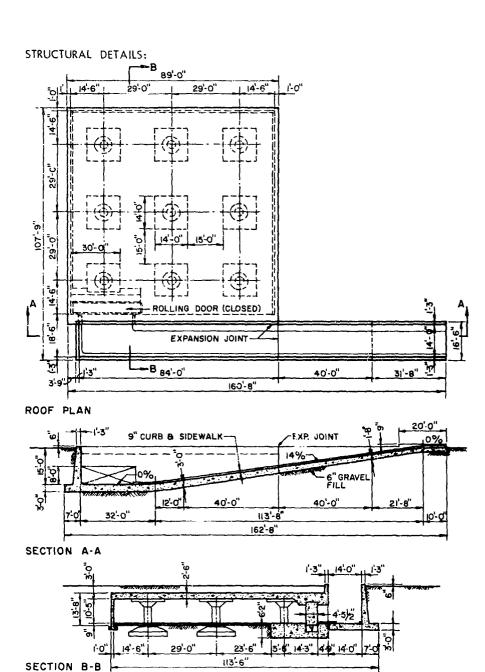
The test structure provided adequate protection against blast and radiation. The rise in interior pressure did not exceed 1.0 psi. The only failures that occurred were the end retaining wall near the entrance and the pneumatic seal around the door frame. Instrumentation consisted of Wyancko pressure gages, Carlson earth pressure gages, dynamic pressure gages, and a self recording pressure gage. Radiation measurements were taken using film dosimeters, gamma radiation chemical dosimeters, and one gamma-rate telemetering unit.

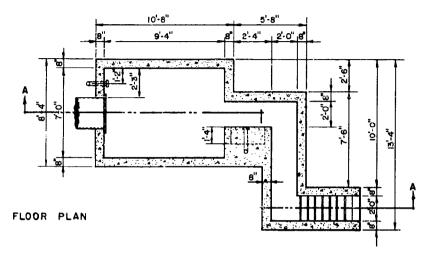
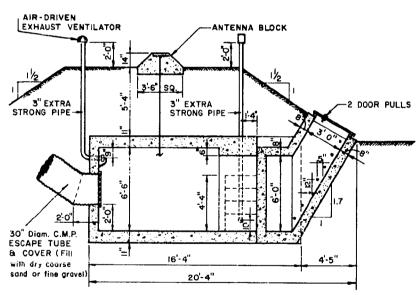
SECTION A-A

Examination revealed that there was little or no deflection in the reinforced concrete members. Permanent damage was confined to the exposed portions of the ventilation pipes, which were bent to a nearly horizontal position.

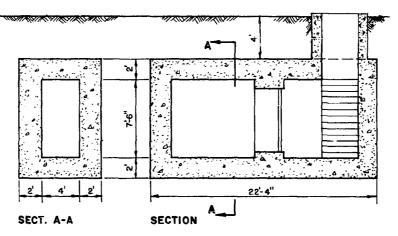
Minor structural damage. Entrance facing away from ground zero was badly damaged.

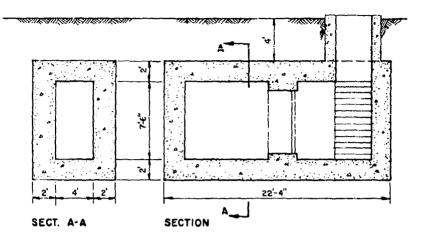
Very minor structural damage to buried portions.

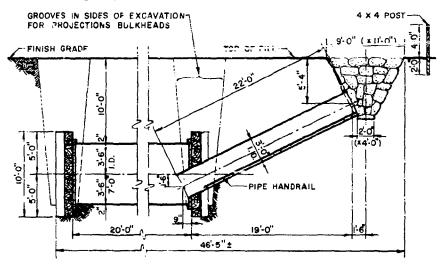
Maximum transient changes in vertical and horizontal diameters measured by the self-recording gages were about 7/8 inch and 3/8 inch, respectively. Maximum residual changes in the same diameters were 3/4 inch and 1/4 inch, respectively. Discrepancies were found between measurements of residual changes recorded by the gages and those obtained visually before and after the event.

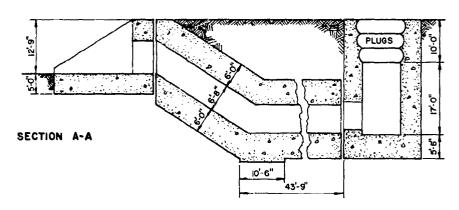
There was no damage from shots "Lassen", "Wilson", and "Hood". Spalling was evident after shot "Owens". Severe cracking occurred from shot "Morgan". Upon completion of the series of tests, the roof was cracked and spalled, thereby exposing reinforcing steel.

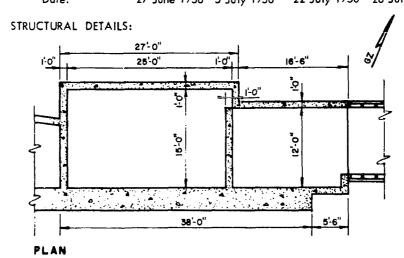
The station received no damage from any of the tests.
